**Flood Control Project Maintenance
Levee Inspections**
LMA District Cover Sheet
Spring 2017 Levee Inspection Results

American River Flood Control District

Spring 2017 Levee Inspection Results

Waterway			Bank	Unit Miles
Unit No. 01 Arcade Creek			Left	2.08
	Spring (March - May)	Summer (June - August)	(September - November) Fall	Winter (December - February)
Unit Maintenance Rating (Fall Only)				
Date of Inspection	3/15/2017 - 5/3/2017			
DWR Inspector	Maksim Khashchuk			
Accompanied By	Ross Kawamura ARFCD

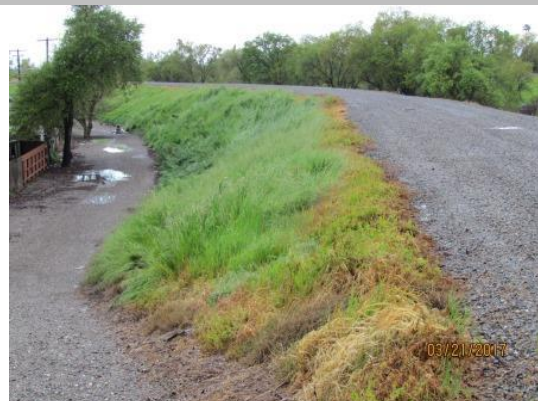
Photo 1 of 1 : SP_2017_NA0001_51_83_20170406_00096.jpg

LM Start	0.69	Rating **	M	Issue No.	83
LM End	0.96	Issue Type +	Ma	Location *	LS
Category	Earthen Levee			GPS Latitude/Longitude	
				Start	End
Item	Vegetation			38.623732 °	38.625096 °
				-121.456566 °	-121.452067 °
DWR ID	DWR_NA0001_01_s_2017_83				
Comment Code					
V1 : Control annual grass and weeds on the levee slopes and easements.					
Inspector Comment

View of the vegetation on the levee slope.

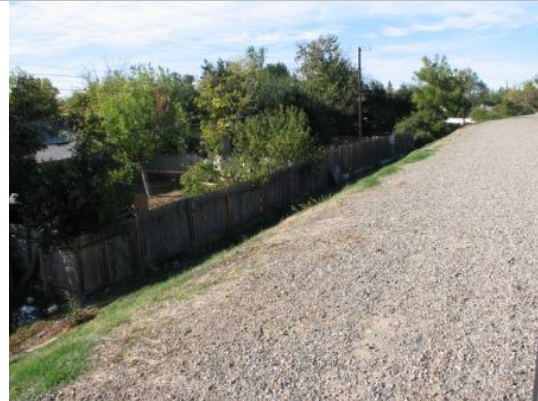
Photo 1 of 1 : SP_2017_NA0001_51_20_20170313_00017.jpg

Photo of solid fences built against the levee slope.

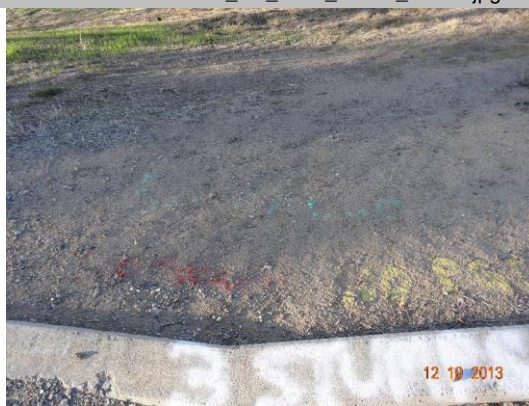
Photo 2 of 3 : UCIP_SP_2017_30085_55488.jpg

Underground service alert (USA) paint markings visible on waterward slope.

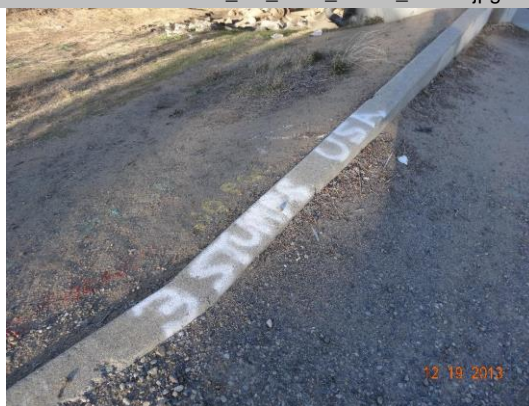
Photo 3 of 3 : UCIP_SP_2017_29732_54977.jpg

Floodwall visible along waterward shoulder.

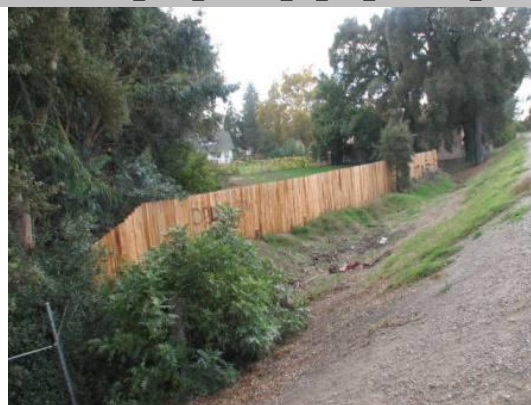
Photo 1 of 1 : SP_2017_NA0001_51_176_20170313_00057.jpg

11/17/2011 Wooden privacy fence built within 15' of the levee toe.

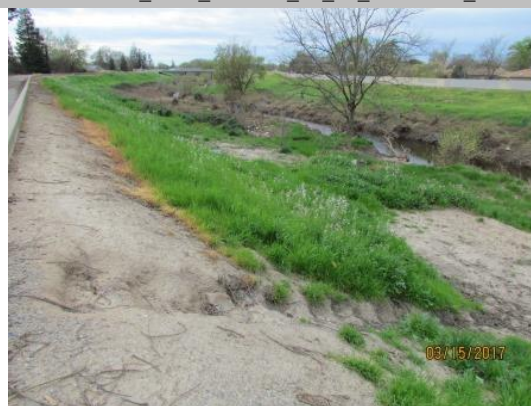
Photo 1 of 1 : SP_2017_NA0001_51_75_20170327_00094.jpg

View of the stairs in the levee slope, looking downstream.

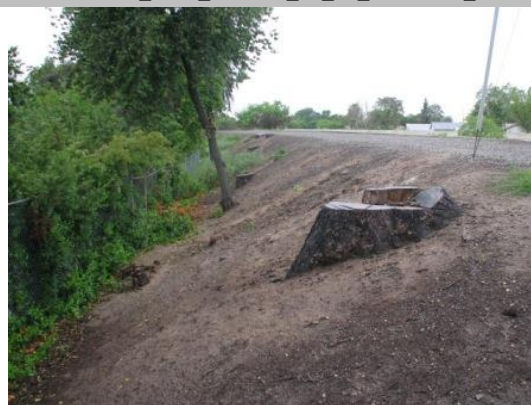
Photo 1 of 1 : SP_2017_NA0001_51_56_20170313_00035.jpg

Several large stumps on levee slope.

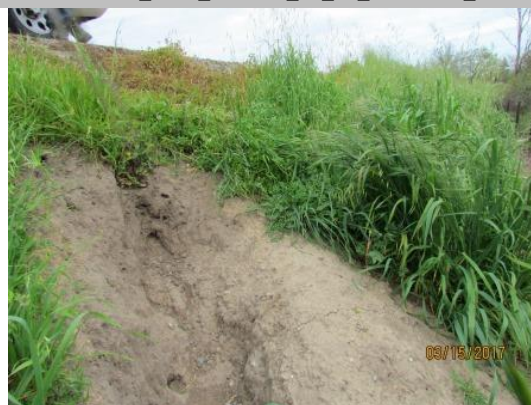
Photo 1 of 1 : SP_2017_NA0001_51_65_20170327_00092.jpg

View of the animal activity on the levee slope.

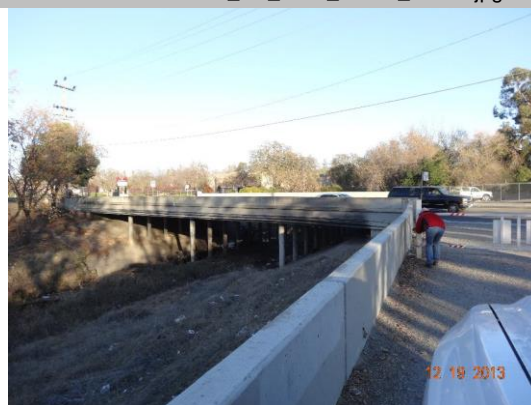
Photo 1 of 3 : UCIP_SP_2017_31185_57091.jpg

Overview markers located on bridge and floodwall indicating crossing through levee.

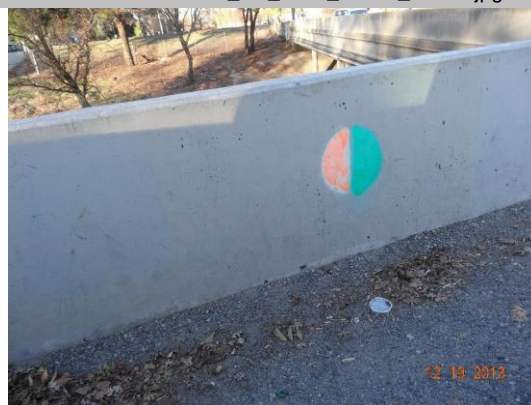
Photo 3 of 3 : UCIP_SP_2017_31185_57089.jpg

Marker of crossing on floodwall indicating crossing through levee.

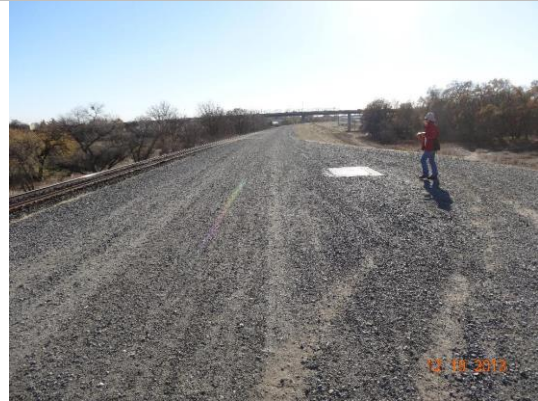
Photo 2 of 3 : UCIP_SP_2017_49533_55041.jpg

Vault located on levee crown.

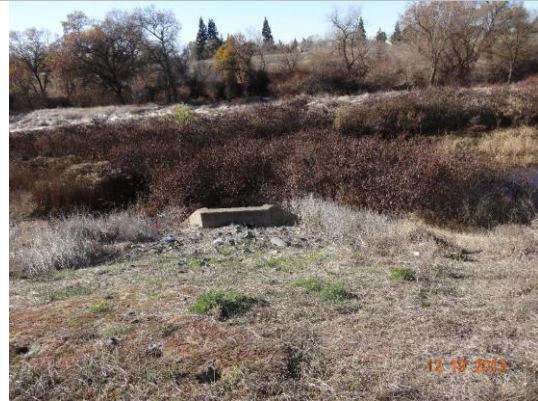
Photo 3 of 3 : UCIP_SP_2017_49533_55040.jpg

Concrete headwall visible on waterward side.

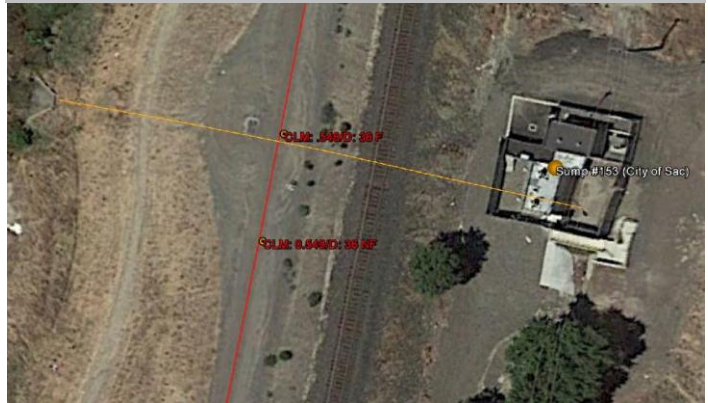
Photo 1 of 2 : UCIP_SP_2017_51428_75580.jpg

Approx. location of USACE O&M original 36-inch located 40 feet downstream from Sump 153.

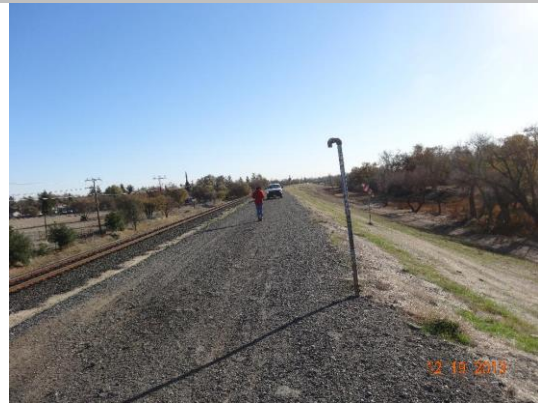
Photo 1 of 3 : UCIP_SP_2017_42132_55451.jpg

Overview of levee crown with utility gas markers on waterward side.

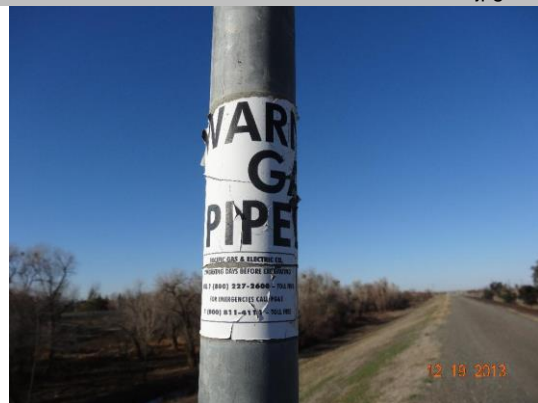
Photo 3 of 3 : UCIP_SP_2017_42132_55452.jpg

Multiple markers visible on waterward side--post with contact information.

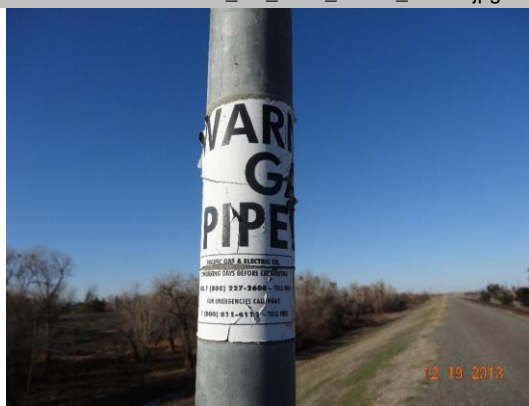
Photo 3 of 3 : UCIP_SP_2017_42130_52767.jpg

Marker located on the waterward side.

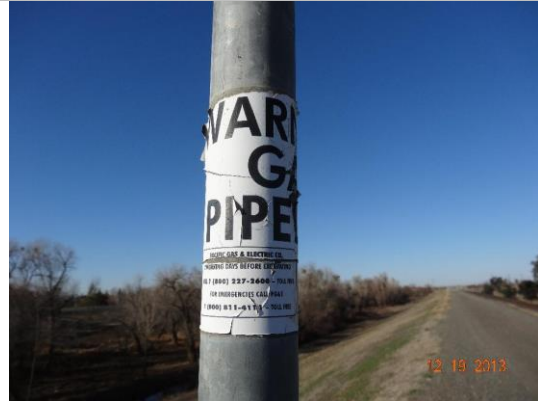
Photo 3 of 3 : UCIP_SP_2017_42131_52773.jpg

Additional marker located on waterward levee crown hinge point.

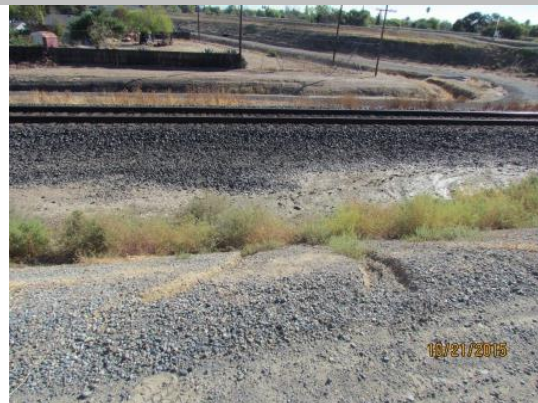
Photo 1 of 1 : SP_2017_NA0001_52_26_20170313_00006.jpg

View of the damaged landside levee slope.

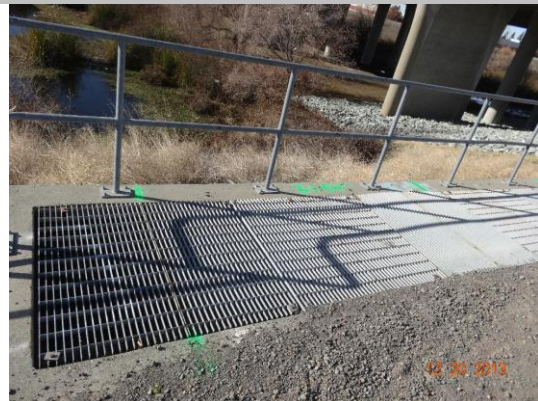
Photo 2 of 3 : UCIP_SP_2017_49862_52891.jpg

Concrete box contains 3-54 inch crossings.

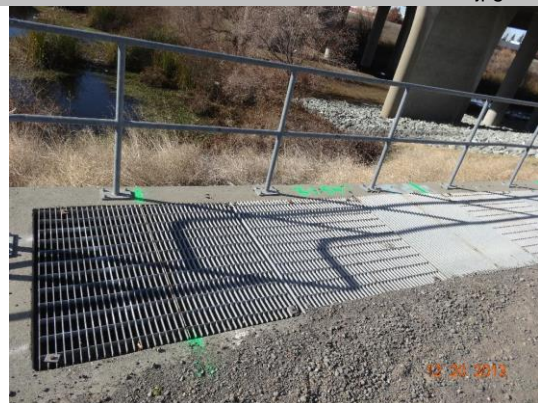
Photo 2 of 3 : UCIP_SP_2017_49863_52901.jpg

Concrete box contains 3-54 inch crossings.

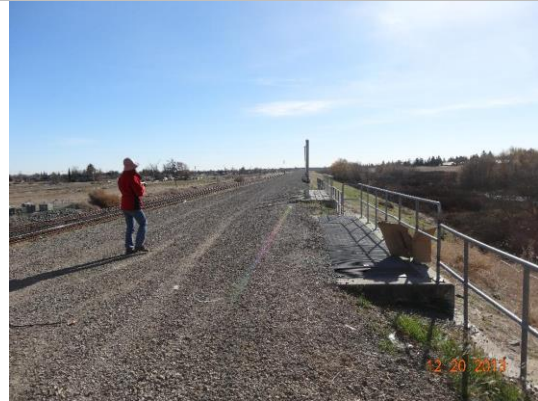
Photo 1 of 3 : UCIP_SP_2017_51261_52912.jpg

Overview of levee crown with two concrete boxes with multiple crossings inside.

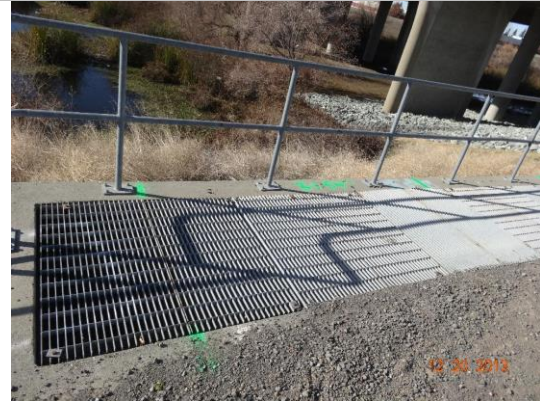
Photo 2 of 3 : UCIP_SP_2017_51261_52910.jpg

Concrete box contains 3-54 inch crossings.

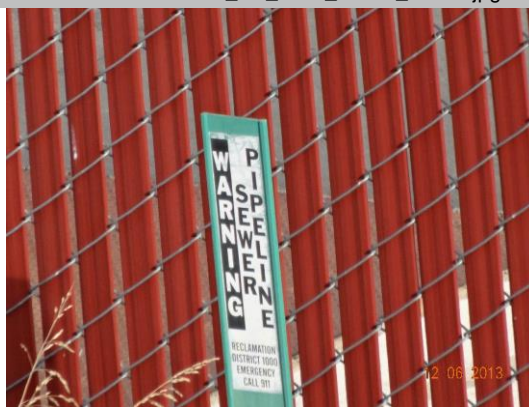
Photo 3 of 3 : UCIP_SP_2017_31225_57132.jpg

Sewer marker visible on landward toe.

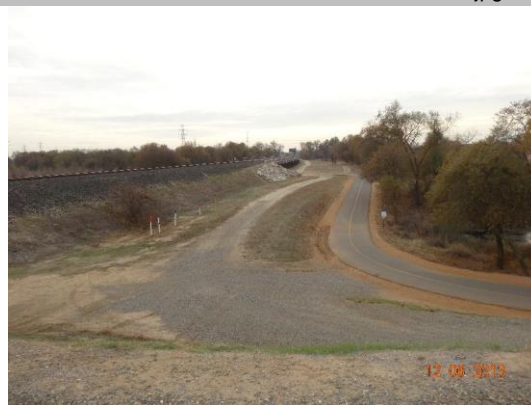
Photo 3 of 3 : UCIP_SP_2017_29827_55139.jpg

Conduit markers visible on waterward side.

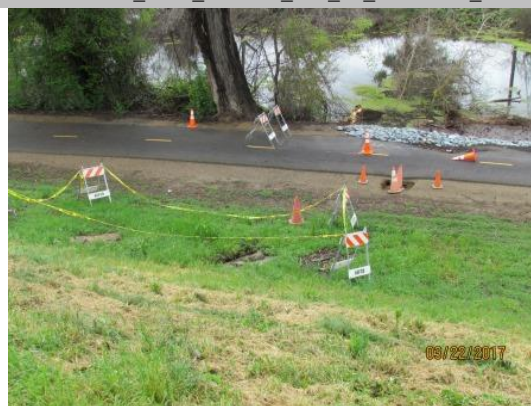
Photo 1 of 1 : SP_2017_NA0001_490_20_20170406_00032.jpg

View of the beaver den at the waterside levee toe.

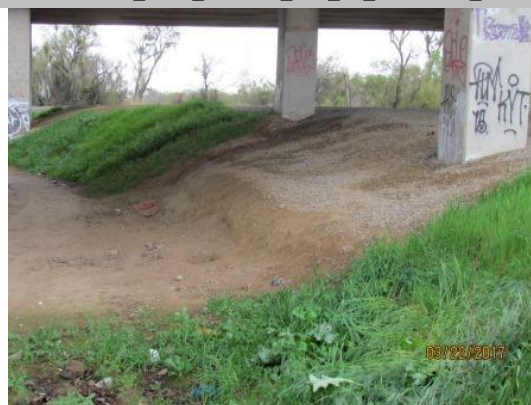
Photo 1 of 1 : SP_2017_NA0001_490_12_20170406_00031.jpg

View of the levee toe cut.

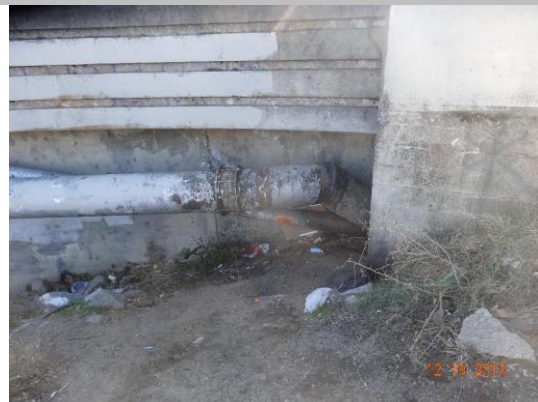
Photo 2 of 3 : UCIP_SP_2017_49935_53495.jpg

Two crossings visible at bridge.

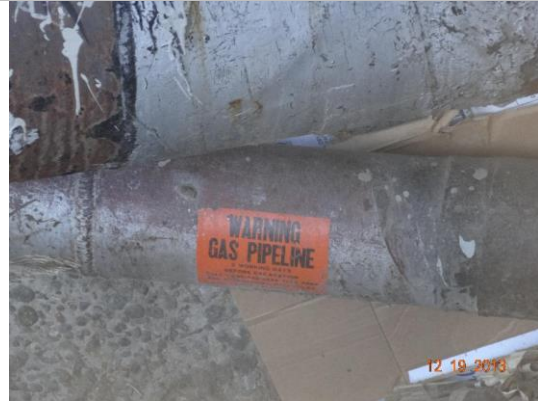
Photo 3 of 3 : UCIP_SP_2017_50050_55420.jpg

Label found on smaller pipe at bridge.

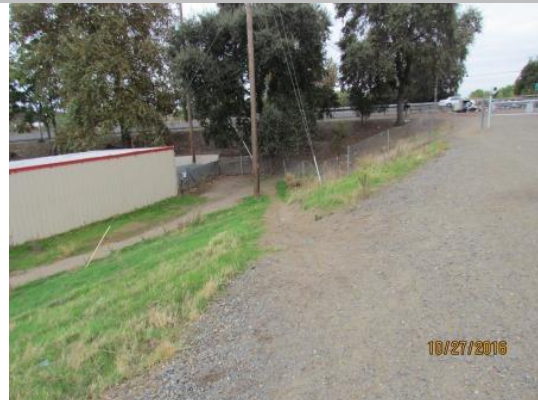
Photo 1 of 1 : SP_2017_NA0001_55_244_20170313_00187.jpg

View of the footpath on the landside levee slope.

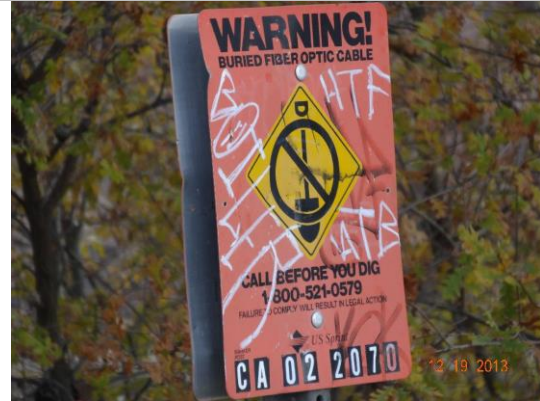
Photo 3 of 3 : UCIP_SP_2017_29927_55260.jpg

Contact information for US Sprint--not MCI as records indicate.

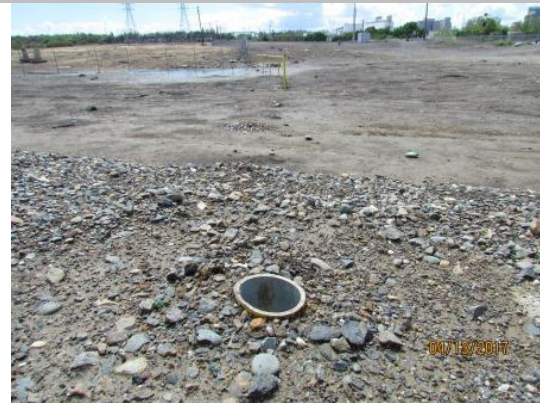
Photo 1 of 4 : SP_2017_NA0001_55_252_20170417_00277.jpg

View of the cut-off post that needs to be removed. Spring 2017

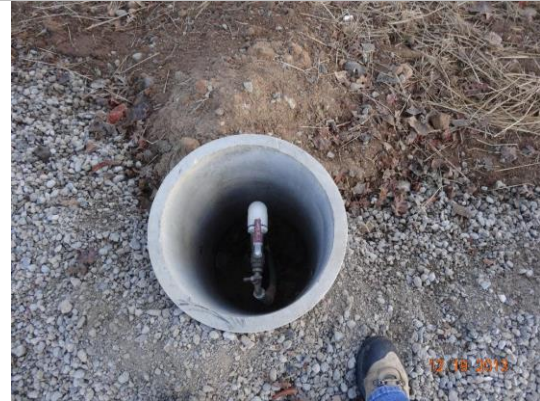
Photo 1 of 1 : UCIP_SP_2017_31445_57487.jpg

Spigot located inside riser located on waterward shoulder.

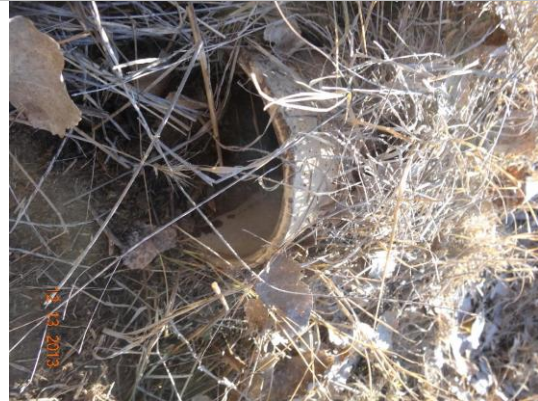
Photo 3 of 3 : UCIP_SP_2017_31254_57221.jpg

Pipe buried through vegetation.

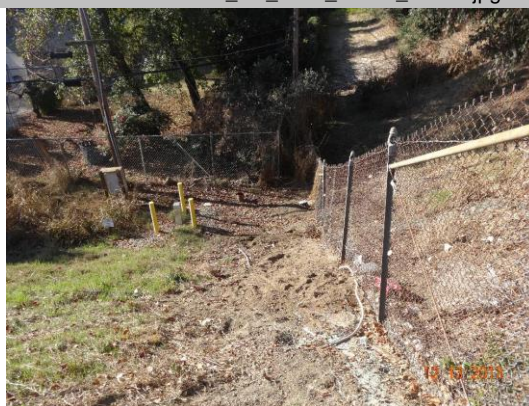
Photo 3 of 3 : UCIP_SP_2017_50051_55295.jpg

Sewer line along fence line on landward side--riser near back fence.

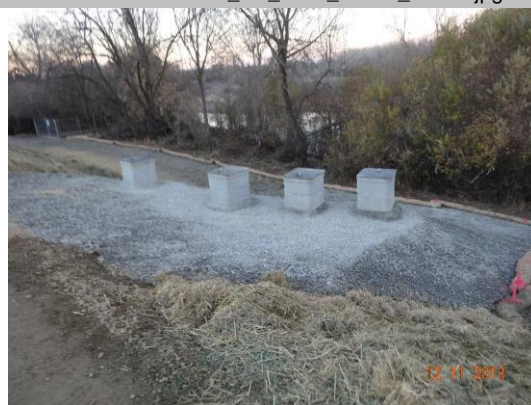
Photo 3 of 3 : UCIP_SP_2017_31449_57497.jpg

View of landward side--service boxes located on landward slope.

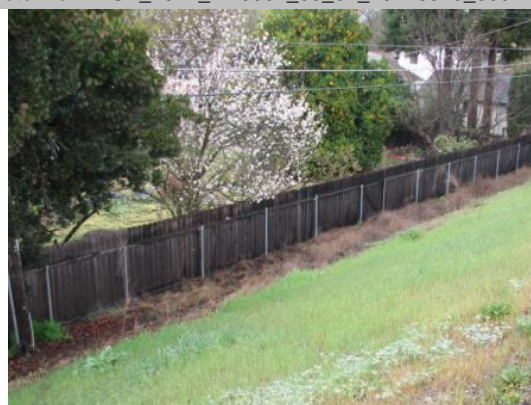
Photo 1 of 1 : SP_2017_NA0001_55_54_20170313_00044.jpg

03/16/2012 Wood privacy fence completely obstructs access and visibility.

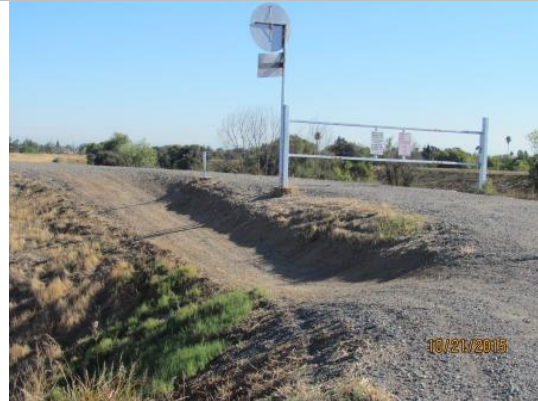
Photo 1 of 1 : SP_2017_NA0001_58_38_20170313_00028.jpg

View of the landside levee slope damaged by motorized traffic.

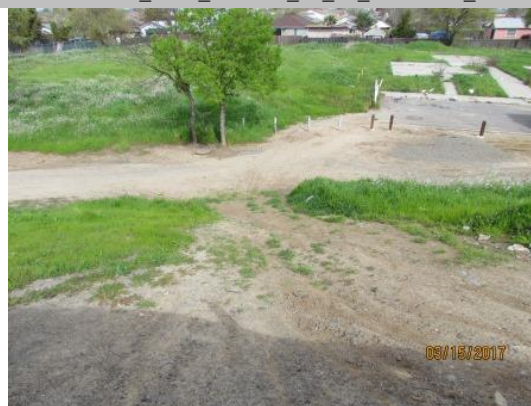
Photo 1 of 1 : SP_2017_NA0001_58_36_20170327_00045.jpg

View of the footpath on levee slope.

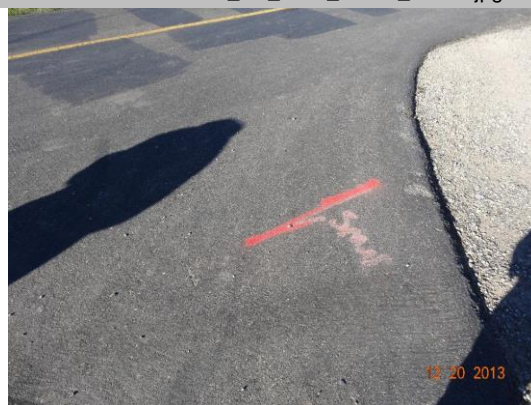
Photo 1 of 3 : UCIP_SP_2017_40803_48512.jpg

Underground Service Alert (USA) marking present on pavement however, unable to verify crossings.

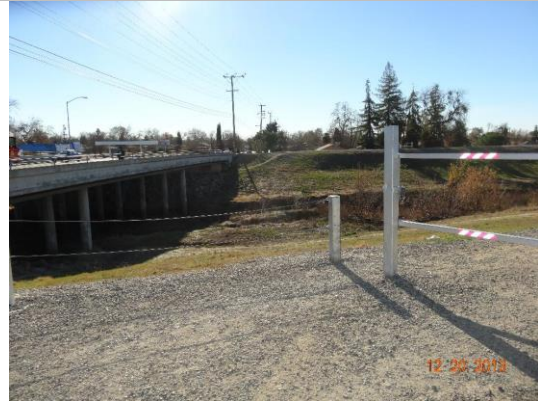
Photo 2 of 2 : UCIP_SP_2017_49933_75854.jpg

No signs of crossing visible through levee or channel.

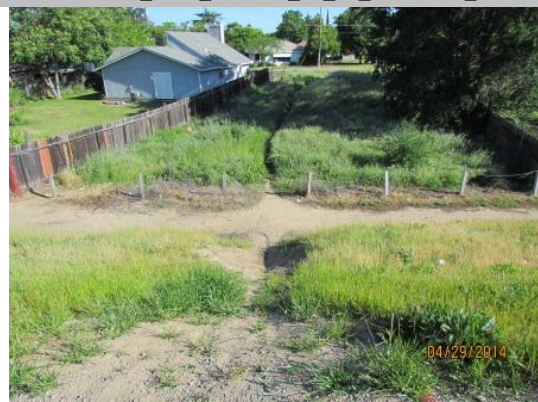
Photo 1 of 1 : SP_2017_NA0001_58_34_20170313_00026.jpg

View of the landside levee slope damaged by foot traffic.

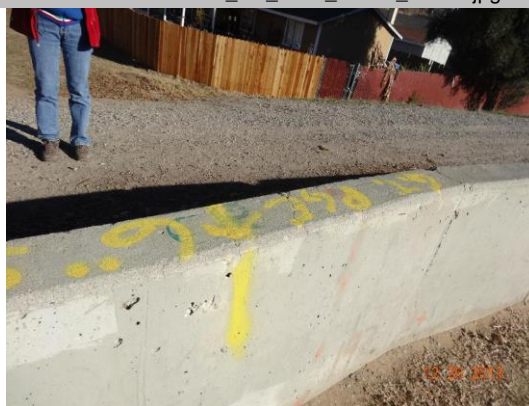
Photo 3 of 3 : UCIP_SP_2017_46795_57524.jpg

6-inch gas line through levee at an unknown depth.

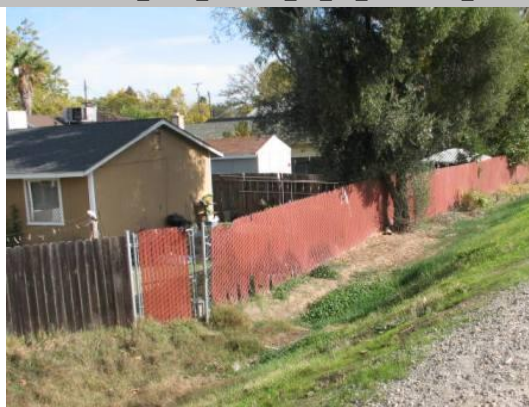
Photo 1 of 1 : SP_2017_NA0001_58_29_20170313_00024.jpg

11/17/2011 Privacy fence is constructed at the toe.

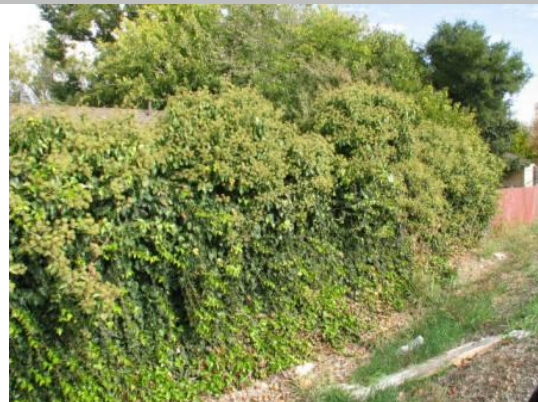
Photo 1 of 1 : SP_2017_NA0001_58_11_20170313_00009.jpg

11/17/2011 Overgrown vegetation obstructs visibility and access.

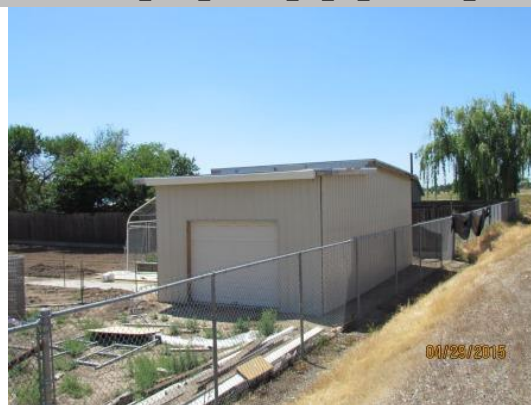
Photo 1 of 1 : SP_2017_NA0001_59_15_20170313_00007.jpg

View of the building within 10 feet of landside levee toe, facing downstream.

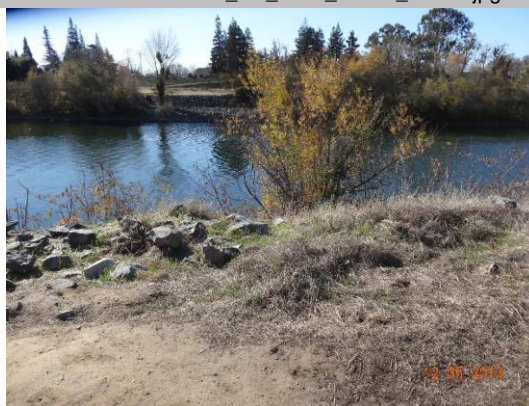
Photo 2 of 3 : UCIP_SP_2017_46085_54712.jpg

View of waterward edge--rip rap used to armor toe.

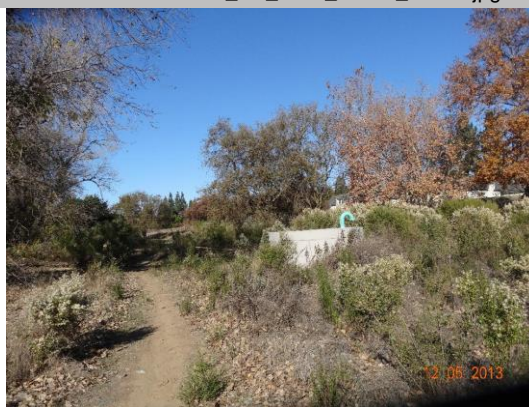
Photo 3 of 3 : UCIP_SP_2017_46085_54711.jpg

View of second concrete cylinder located on waterward berm.

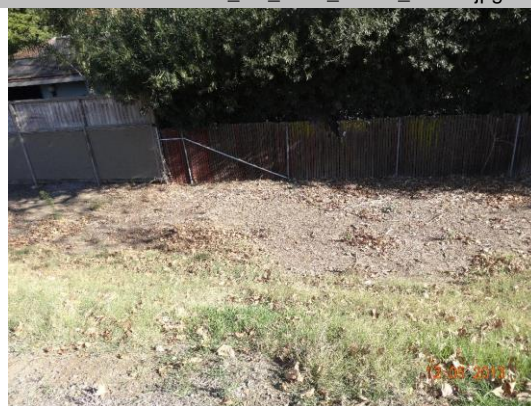
Photo 3 of 3 : UCIP_SP_2017_31309_57336.jpg

Landward side toe cleared.

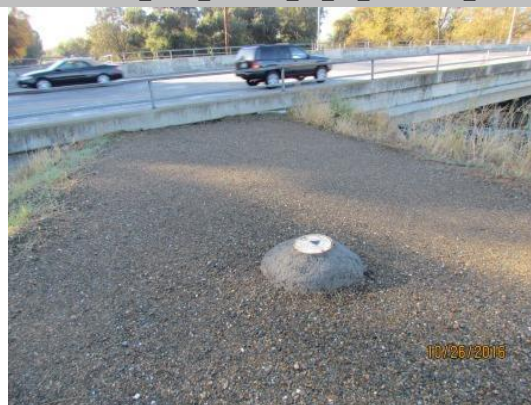
Photo 1 of 1 : SP_2017_NA0001_60_23_20170313_00005.jpg

View of the monitoring well on the levee crown.

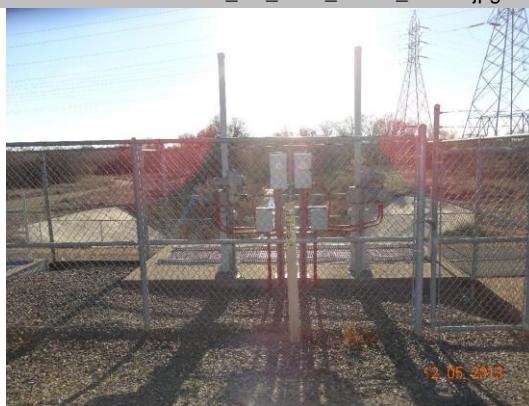
Photo 1 of 3 : UCIP_SP_2017_31306_57333.jpg

Concrete box and electrical boxes located on waterward shoulder.

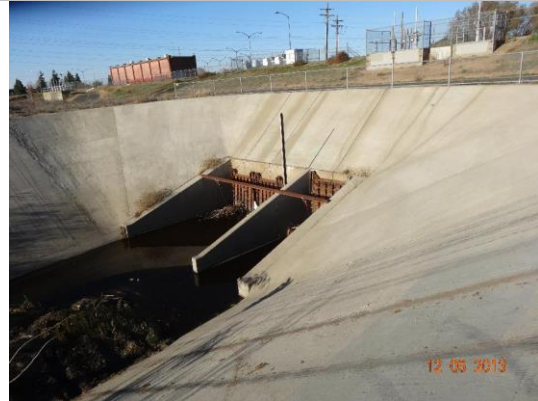
Photo 3 of 3 : UCIP_SP_2017_31306_57332.jpg

Concrete headwall located on waterward toe.

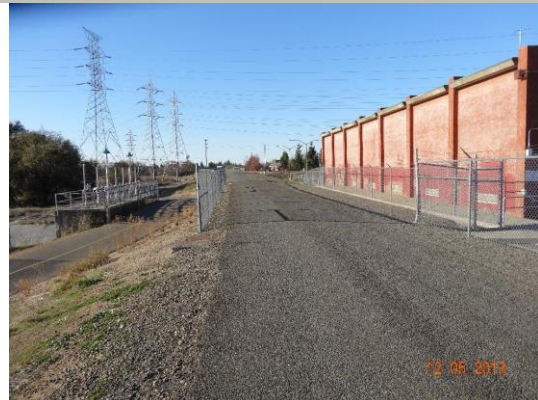
Photo 1 of 2 : UCIP_SP_2017_31307_57335.jpg

View of concrete service box located on waterward shoulder.

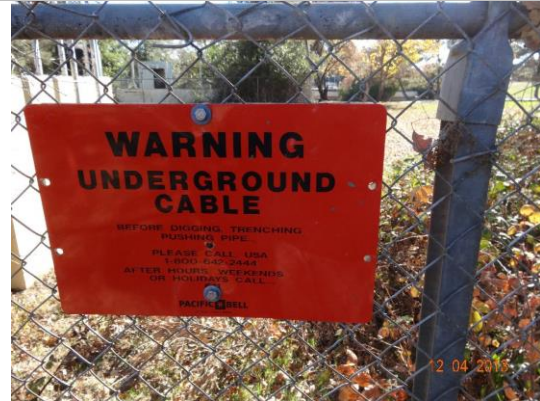
Photo 3 of 3 : UCIP_SP_2017_26299_47573.jpg

Sign for unground cable with contact information.

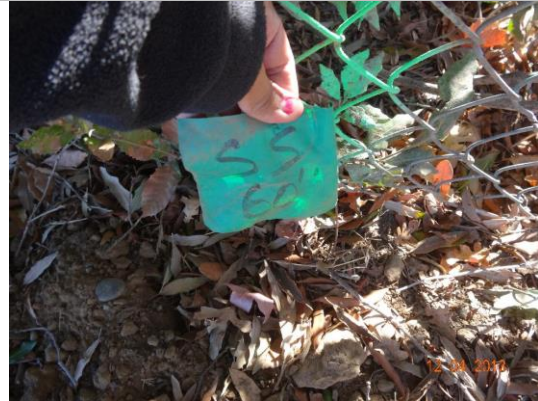
Photo 3 of 3 : UCIP_SP_2017_26426_47984.jpg

USA marker indicates 60 inch line through levee.

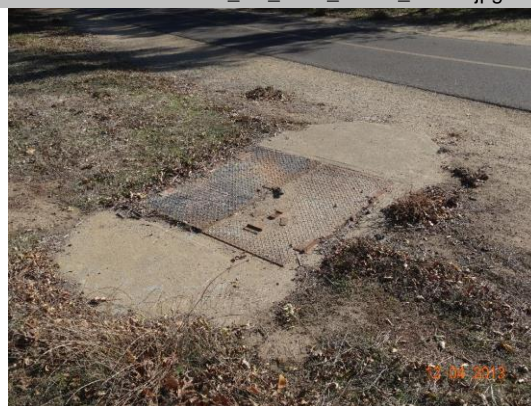
Photo 3 of 3 : UCIP_SP_2017_41548_54883.jpg

Concrete box located on waterward side near paved trail.

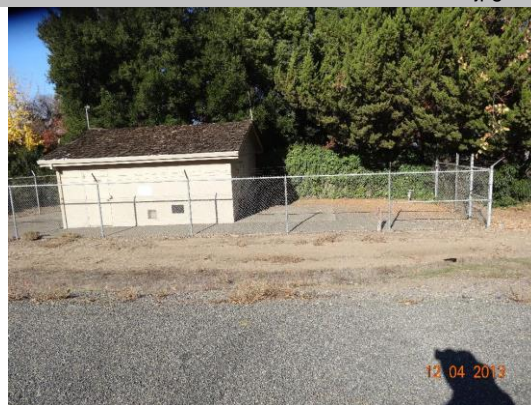
Photo 1 of 3 : UCIP_SP_2017_41546_57290.jpg

Structure located on waterward side.

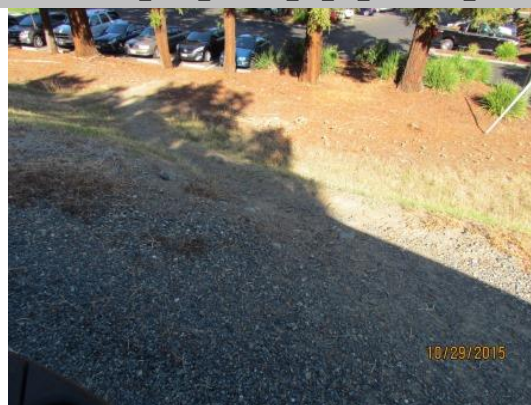
Photo 1 of 1 : SP_2017_NA0001_61_21_20170313_00003.jpg

View of the footpath on the landside levee slope.

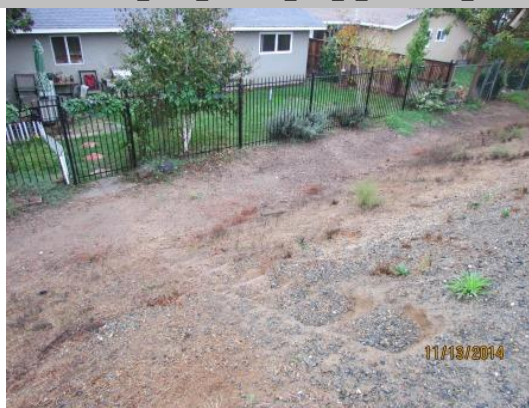
Photo 1 of 1 : SP_2017_NA0001_438_1_20170313_00001.jpg

View of the stairs on the landside levee slope.

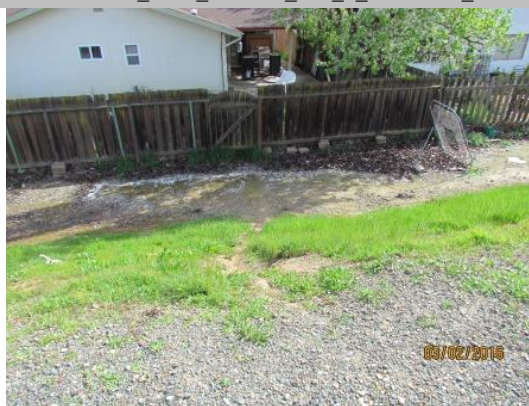
Photo 1 of 1 : SP_2017_NA0001_438_4_20170313_00004.jpg

View of the footpath on the landside levee slope.

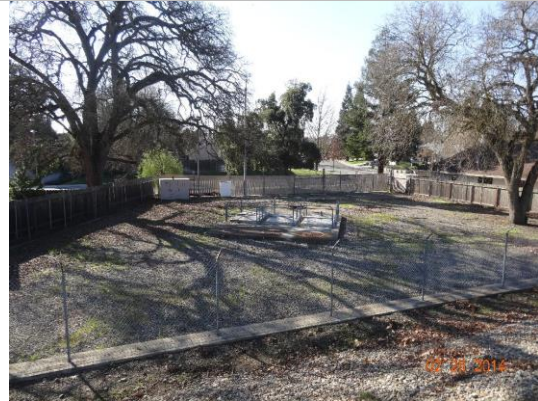
Photo 3 of 3 : UCIP_SP_2017_30540_56231.jpg

Concrete vault located on landward side.

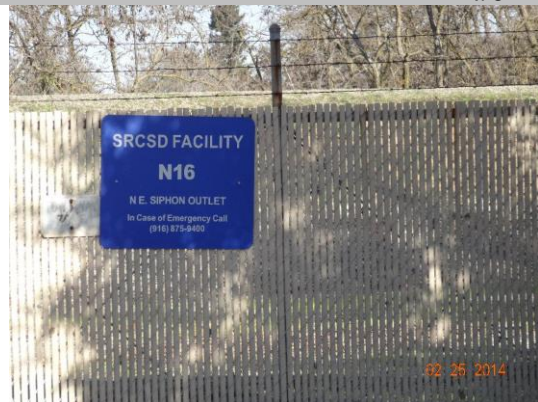
Photo 1 of 3 : UCIP_SP_2017_46994_56229.jpg

SRCDS Facility N16, NE Siphon Outlet, sign visible from Mira Del Rio Drive.
